# ASPECTS CONCERNING THE BEHAVIOUR OF BUILDINGS DURING TIME

**Arsene Cornel**

**Abstract.** Monitoring the way constructions behave over time is a corollary of the construction activity, constituting an obligation of the builder in relation to the works he has carried out and has been practiced, in various forms, since the beginning of construction. This paper presents aspects and manifestations that appeared in the process of monitoring a construction that was "disadvantaged" from the start due to the nature of the foundation land.

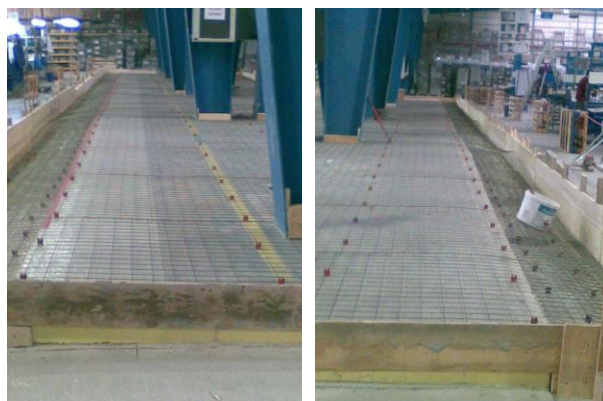
Fig. 2 Cutting out the floor for reprofiling

The current configuration of the construction was obtained in three stages. Although the constructive solution adopted was in accordance with the conclusions of the geotechnical studies carried out (Arsene et al., 2017), there were problems of differential settlement, mainly of the floor but also of seven of the pillars of the resistance structure, since the first stage of exploitation of the construction (Arsene, 2023).

The process of differential settlement of the floor required the making of some cutouts of it next to the central pillars of the resistance structure (areas where the floor has minimal settlements) and periodic reprofiling works, to ensure the horizontal plane of the floor, necessary for the operation of the production lines (Fig. 2).

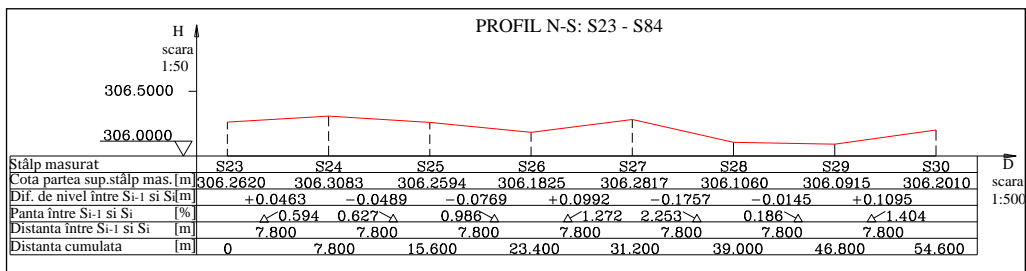
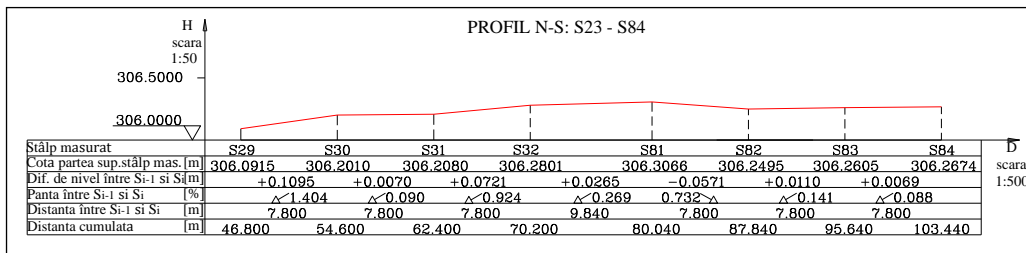
Fig. 4 Longitudinal profile S23 – S84

The results obtained show that the differential settlement of the pillars during the exploitation period determined the modification of the geometry of the structure. The longitudinal N-S profile made for the row of central pillars S23-S84 clearly indicates the discontinuity zones caused by the differential settlement of the pillars: S25, S26, S28, S29, S30, S31 and S82. The profile represents the situation at the top of the pillars, to indicate how the cover's geometry has been affected, but the situation is similar at the base of the pillars.

To be able to fit it in the page, in Fig. 4 the profile was divided into two: from pillar S23 to pillar S30 (Fig. 4.a.) and from pillar S29 to pillar S84 (Fig. 4.b.) (with a continuity zone S29-S30 between the two sides).

The highest settlement values are recorded by pillars S28 and S29. The two pillars recorded higher settlement values from the beginning. Over time, the periodic

settlement values of pillar S29 decreased, while the rate of settlement of pillar S28 remained almost constant at the value of 1mm/month.

In order to not affect the resistance structure by the occurrence of additional loads in the beams, a decade ago the pillar was raised, by adding a metal piece at the base, by 160mm. By continuing the settlement process at the same speed, the pillar S28 is currently almost 5cm higher than its pre-lift position, settling 111mm in 120 months.

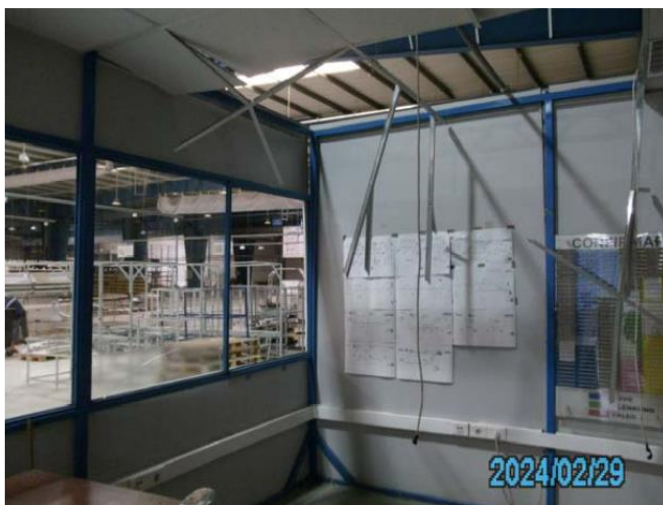
After a one month interval from the date of determining the height at the base and at the top of the pillars in the office constructed with the light structure around the pillars S30 and S31 it was damaged in the NW corner by destroying the ceiling and breaking the glass in the corner (Fig. 5).

Fig. 5 The damaged NW corner

The imbalance between the settlement type on the two sides of the office caused the floor on the west side of the office to fracture along the boundary between the original portion and the extended portion, which led to the destruction of the ceiling and the breaking of the glass in the NW corner of the office.

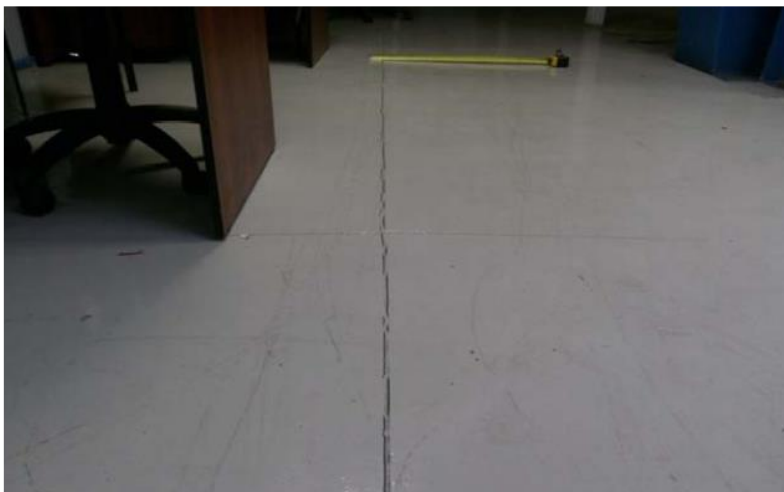
At the same time, a crack appeared in the floor with an opening of 7÷10 mm along the entire length of the office (Fig. 6).

Fig. 6 Crack in the office floor

As the process of differential settlement of the floor continued, on the east side of the office, at the junction between the lower part of the office floor and the floor of the production space, a fracture line appeared caused by the pronounced settlement of the floor of the production space in relation to the office floor (Fig. 7 *a.*, *b.*); on the west side (Fig. 7 *c.*) the settlement of the floor in the production space occurred in solidarity with the extended portion of the office floor.

Thus, if on the east side in the interval October 2019 - February 2024 the settlement of the lower part of the office floor was of -41mm in the NE corner, respectively of -73mm in the SE corner, on the west side the settlement of the lower part of the office floor (in same interval) was of -148mm in the NW corner, respectively of -161 mm in the SW corner.

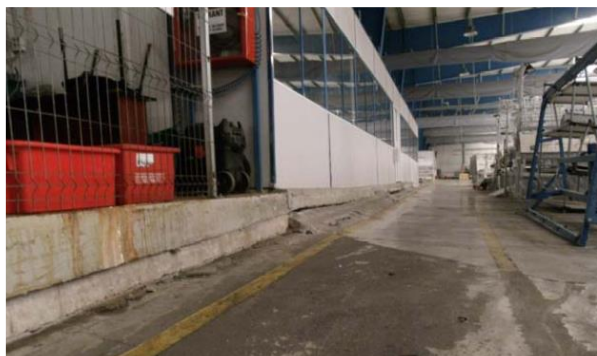
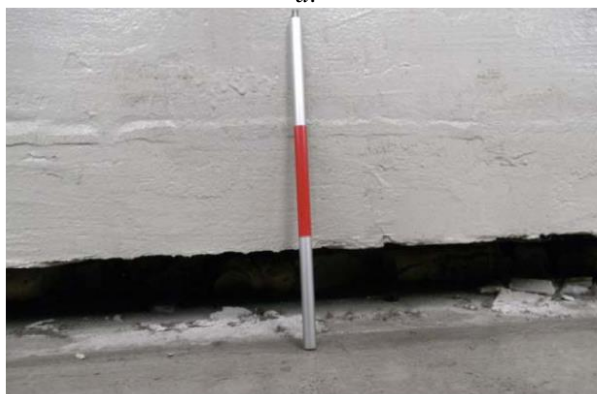
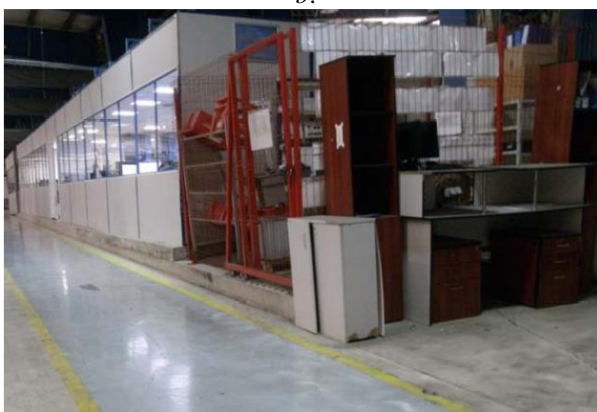
Fig.7

The settlement of pillars S30 and S31 in the damaged area is null. Therefore, it was not the vertical movement of the pillars that moved the floor. The the cutouts of the floor next to the central pillars were done symmetrically in relation to the pillars (Fig. 2). When the office was built, the surface resulting from the cutout (whose height was at the level of the pillars) was extended only on the west side by approx. 1.5 m.
