RESEARCH ON BEHAVIOR OF TORRENTIAL CORRECTION WORKS IN THE ANIEȘ HYDROGRAPHIC BASIN

Pupeza L., M. Dirja, T. Salagean, Adela Hoble

Abstract. In Anieș basin, first torrential correction works were carried out in 1988, on Butucilor Stream, with waiver of narrow gauge forest railways and open forest road Anieș. This work consisted of two thresholds in performance with a height of 2 meters, connected together by trapezoidal drains and the upstream side of a dam with a height of 6 feet with 2 drain holes that could close using metal gates. The works were made of stone masonry with cement mortar. In the next phase, the years 1988-1997 were executed torrential correction works upstream the Butucilor Stream, on the streams Deluțului, Brazilor and Lupilor, consisting of a dam with a height of 3 meters and a channel connection. These works were well behaved, but after repeated floods in the basin, silt transported have exhausted retention capacity and currently works cross some channels are clogged drain, sometimes being destroyed masonry, is even installing vegetation on the shoulders dams. Currently, due to dynamic torrential processes, torrential correction action on Anieș basin, continu

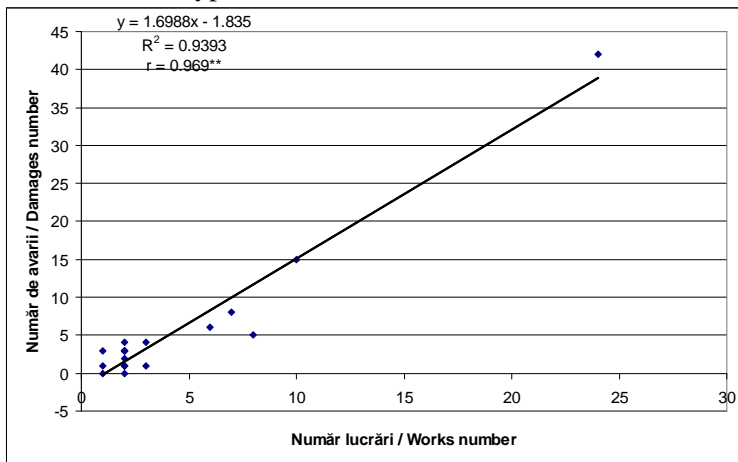
After the number of jobs affected, most (24 in number) are affected by clogging slab, the following being affected by rupture (15 in number). After the number of constitutive parts affected by the number of failures is as follows: 25 parts are affected by cracks, 24 parts by tearing or warping and 22 the lack of constructive elements.

Fig. 1. Correlating the number of works by the number of failures recorded

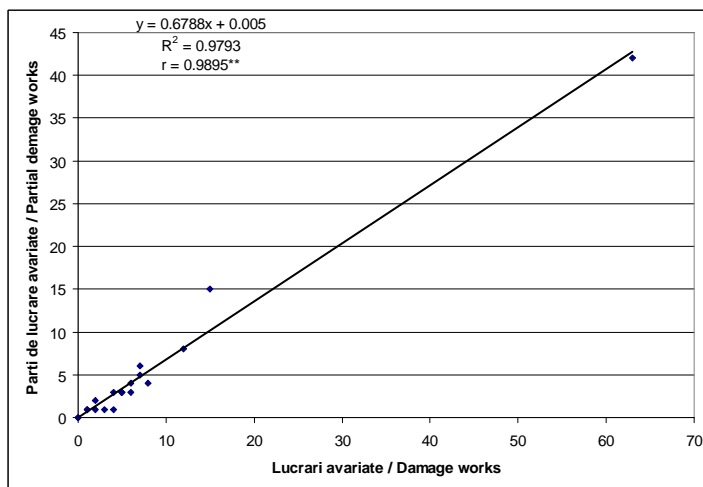
Fig. 2. Correlation number of works damaged by the number of parts of the work damaged

Correlation between the number of faults recorded and number of shares affected constitutive of work is very close, because the variation in the number of technical works from one valley to another and torrential constitutive parts affected are also different in number from one valley to another arranged in its basin.

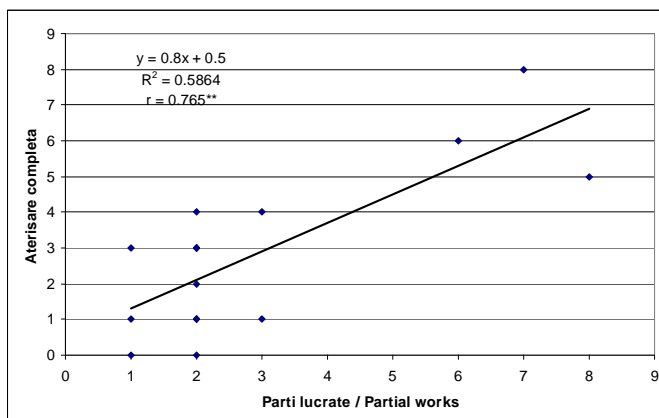
Fig.3. Correlation of number parts of the work carried out by the number of fully formed aterrissements

Aterrisments formation, strengthens the hydrographic by decreasing slopes and bed expansion due to raising thalweg. Due to irregular intervals of time that a work clogging occurs, it may be influenced by existing vegetation in the basin during heavy intensity or uniformity of soil and substrate petrographic crossed the torrent respectively.
