Original Article

Rehabilitation of the Agricultural Lands Degraded by Uncontrolled Human Intervention in Transylvania

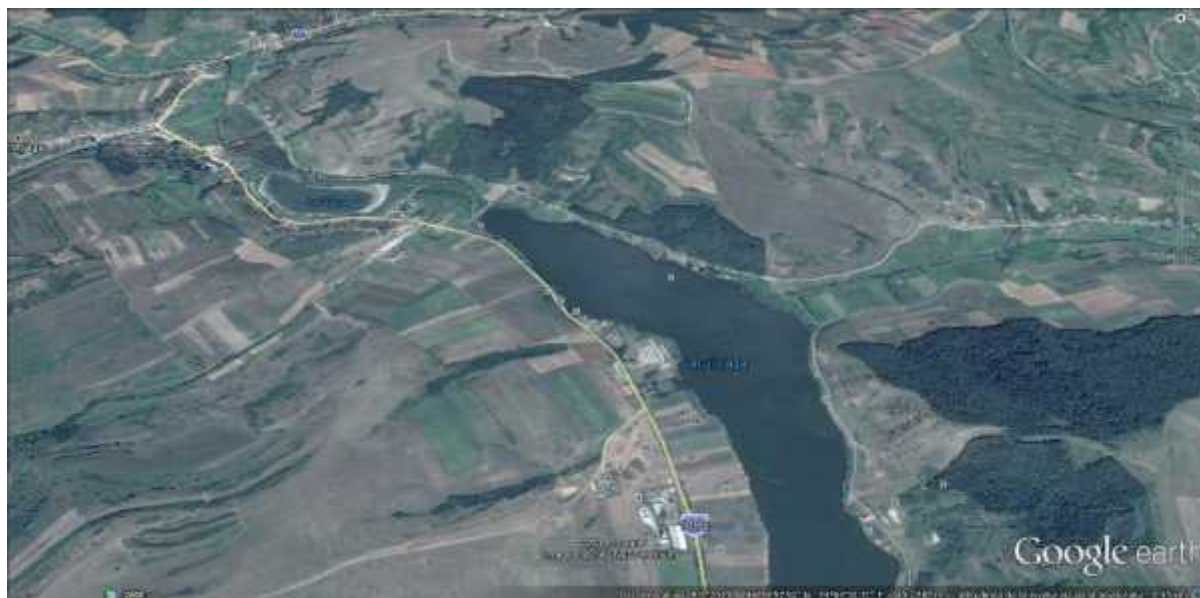
Figure 1. Bordering the degraded land surface in the area [12]

The figure below illustrates the administrative settlement of the studied area on Google Earth (Fig. 1) and in Photo 1 it is displayed the area with the land degradation level by aggressive human intervention from the Natural Gas Company Romgaz SA Media .

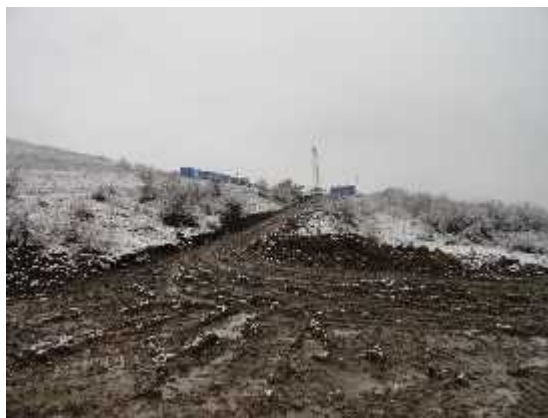
Photo 1. The destruction of land by human activity from the Natural Gas Company Romgaz SA Media

To develop this research, there were performed (Photo 1) measurements, observations and soil sampling at depths of 0-20 cm, 20-40 cm, 40-60 cm, with the drill-type pedoagrochemical probe for pedoagrochemical analysis, from the disturbed land after human intervention from the National Gas Company Romgaz SA Media and from the neighboring undisturbed land, respectively a proxicalcaric regosol, to correctly determine the type of degraded soil and the complex ecological restoration measures to be taken for its rehabilitation and returning into agricultural use.

Pedoagrochemical description of the anthropogenically disturbed soil - eroded antrosoil (Photo 1, Table 1 and record of evaluation, Table 2): the eroded antrosoil identified in the anthropic disturbed perimeter by man-made transformations due to aggressive interventions with heavy machinery from the National Gas Company Romgaz SA Media in the area and to soluble salts used in the drilling technology.
