Original Article**Landslides Monitoring by Using Topographical Surveying and 3D Laser Scan****SZILAGYI Istvan Botond, Marcel DIRJA, Adela HOBLE***University of Agricultural Sciences and Veterinary Medicine of Cluj-Napoca, 3-5 Manastur Street, 400372, Cluj-Napoca, Romania*Received 20 April 2015; received and revised form 15 May 2015; accepted 20 May 2015
Available online 20 June 2015

Keywords: landslides, hazard maps, digital terrain model (DTM).

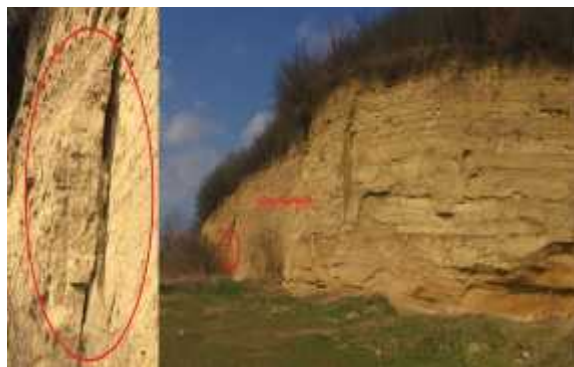
Fig. 8. Image of the zone scanned with 3D laser scan technology

points. Due to difference mentioned before, it was necessary to take a detailed measurement of a zone by using 3D laser scan (Fig. 8).

Using the 3D laser scan was created panoramic views, point clouds, and analyzes of the scanned geometry.

The results of the 3D model showed insignificant chronological differences (up to 4.03 m) between RTK and GNSS coordinates determination mode at 3 months period between 1st and 2nd measurement phase (January to April 2015). By analyzing the 3D laser scan data was a 133.40 mm distance between stable layer and unstable clay layer.
