# THE TOPOGRAPHICAL ANALYSIS CONCERNING THE VERTICAL MOVEMENT OF A ROAD BRIDGE UNDER LOAD

**Abstract.** The vast majority of our country's road bridges were built at least three decades ago, faults and alterations being produced over time. To operate safely it is necessary to determine the degree of stability and the precautions needed. This paper presents the analysis of vertical movements for such an bridge, determined by topographic methods in order to establish the proper conditions under which it can be further exploited.

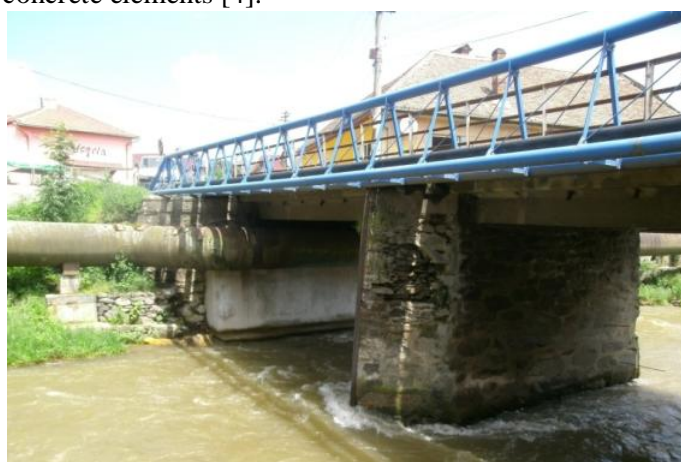
Fig. 1. Sadu road bridge

This paper presents measurements made on a bridge with the length of 17,5m and the width of 6.5 m, located in the center of a town. The bridge was built with reinforced monolith concrete consisting of two abutments and a pile that supports four beams of reinforced monolith concrete, and over them a reinforced monolith concrete plaque is installed, and over it the asphalt was poured [4] (Fig. 1.).

The bridge was built in the seventh decade of the twentieth century, degradation appearing over time. Thus, facing the prop on the right bank, the armour is partly uncoated; also there is some segregation of the concrete in some parts, vegetation has appeared on the concrete elements [4].

In the interpretation of the obtained data was found that the bridge is functional according to the class for which it was designed, however, to comply with current rules of classification it is imposed a superstructure widening from 6,50m to two lanes of 3,50m and a comfort optical space of 2x40cm, adding also two sidewalks with a minimum width of 1m with safety fences to separate it from the road; at the same time work is needed to strengthen the infrastructure, given the fact that the foundations are submerged under water and the elevations present degrading in masonry [4]. Another alternative, for placing the structure in the appropriate current class, is eliminating the pile, strengthening the abutments and replacing the superstructure [4].

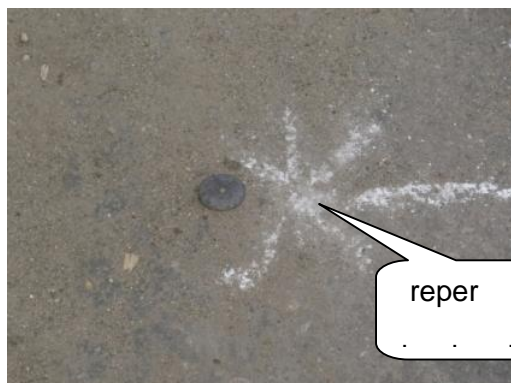
Fig. 2. Reper de nivelment  
Leveling landmark

As a leveling point, the landmark located near the bridge was used (Fig. 2.), the control trademarks were materialized from concrete nails embedded in the bridge (Fig. 3.).
