TRACKING STABILITY OF ARCH DAMS THROUGH MICRO-TRIANGULATION METHOD

Ortelecan M., T. Sălăgean, N. Pop, Rodica Joldiș (căș. Bădescu)

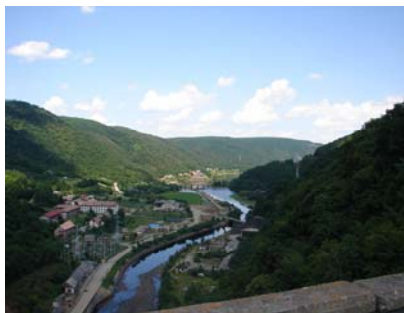
Fig. 1. View of downstream

If the track networks are stable and optimal set, measurement equipment can provide the required precision, in the case when the effectuated measurements are of high quality and the mathematical model used for efficient processing of land data is performing. This paper aims to track the stability of the Tarnița dam made after a scheduled basis depending on: the season, atmospheric condition, the rate in the lake, etc. In Figures 1 and 2 are views of the area downstream and upstream of the dam.

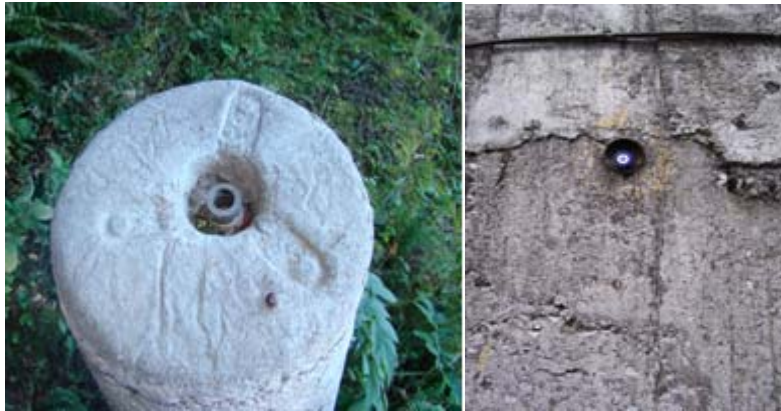
Fig. 4. Pilaster with clamping device

Pilasters on which are alternatively installed the total stations and the targeting signals, are built of solid concrete and should be embedded in the bedrock (Fig. 4). At the top of the pilasters, after their concreting, is placed a special plate. To protect the upper parts of these pilasters, metal protection caps are positioned in the period in which there are no measurements.

In order to perform observations on the horizontal plates, are alternatively placed the total stations and the signals to which are taken visas from other pilasters.

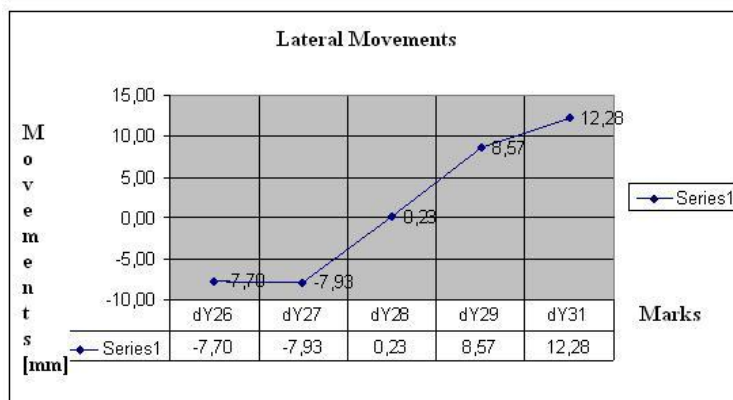
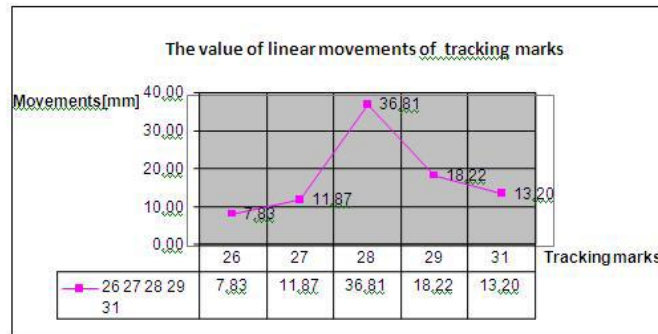
By making reports between the movement and the determination accuracy, were chosen as "fixed", points I, IV, V, VI, from which was compensated the complete network with tracking marks (Figure 5) obtaining an accuracy of about 2 mm . After the calculations were obtained the tracking marks values, presented in the following diagrams.

Following the diagram of downstream – upstream movements and of linear movements, it appears that the movement of mark 28 is bigger than all other marks, which is practically impossible, given the construction of concrete dam.

Given the error ellipse for mark 28, the unauthorized high movement of the point was due to previous coordinates coordinates, towards it is established the movement in current stage.
