# ASPECTS CONCERNING THE BEHAVIOUR OF BUILDINGS DURING TIME

**Arsene Cornel**

**Abstract.** Monitoring the way constructions behave over time is a corollary of the construction activity, constituting an obligation of the builder in relation to the works he has carried out and has been practiced, in various forms, since the beginning of construction. This paper presents aspects and manifestations that appeared in the process of monitoring a construction that was "disadvantaged" from the start due to the nature of the foundation land.

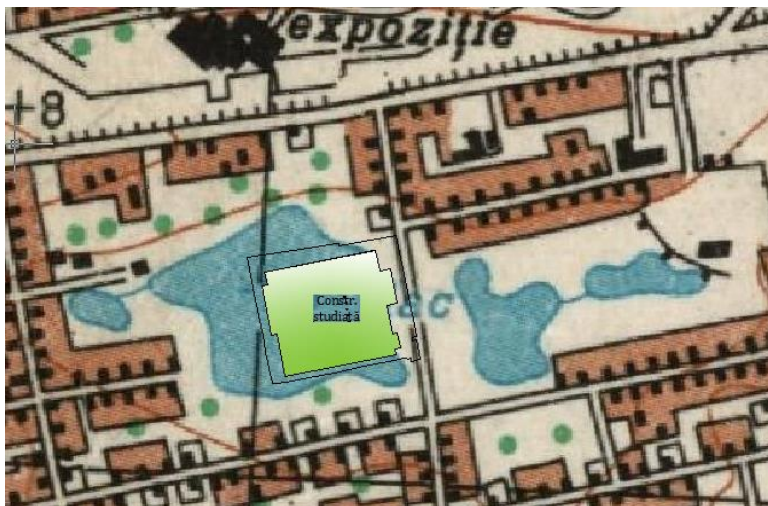
The studied construction is located on a difficult foundation ground. Until the 7<sup>th</sup>-8<sup>th</sup> decades of the last century, the land was occupied by a lake (Arsene et al., 2015) (Fig. 1).

Fig. 1 The status of the area where the construction was located until the 7<sup>th</sup>-8<sup>th</sup> decades of the 20<sup>th</sup> century

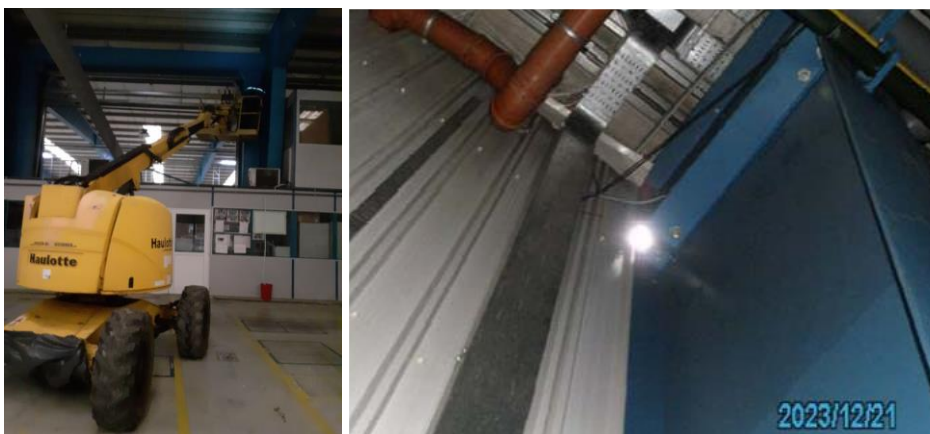
The differential settlement in the case of the pillars produced irregularities regarding the slope of the cover panels. To determine the slopes along the row of pillars, measurements were made to establish the height at the base of the pillars, their size and the distances between the pillars; the determination of the height at the base of the pillars was carried out under the same conditions as those for establishing vertical displacements, and a laser distomate was used to measure the size of the pillars and the distance between them, with reflective targets fixed to the upper part of the pillars (Fig. 3).

Fig. 3 Fixing reflective targets
