Tracking the Behavior of the Torrential Works on the Valleys of the Upper Basin of the Someșul Mic River

Marcel DÎRJA, Tudor SĂLĂGEANU, Florica MATEI

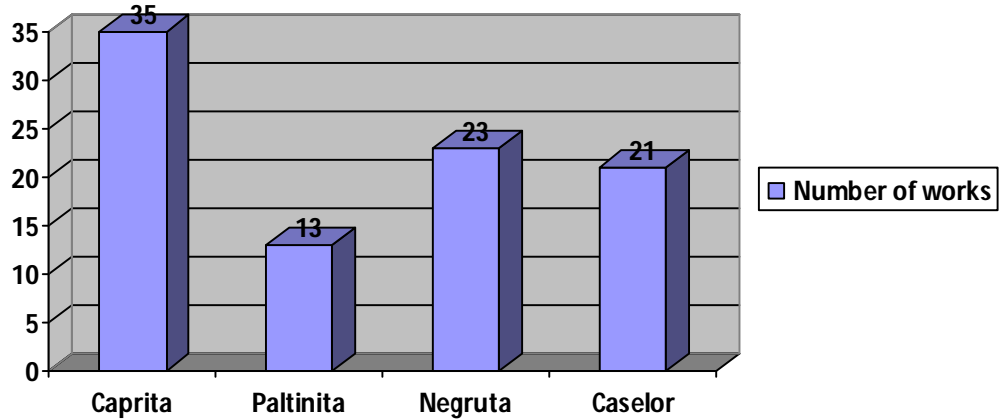
Fig. 1. The number of hydrotechnical works on each valley taken into study

On the 4 valleys taken into study are present a total of 92 hydrotechnical works for torrent correction (Fig. 1).
